## EXPERIMENTAL INVESTIGATIONS ON DETERIORATION OF HISTORIC BRICKS FROM SELECTED MUGHAL MONUMENTS OF KHYBER PAKHTUNKHWA, PAKISTAN

### ABSTRACT

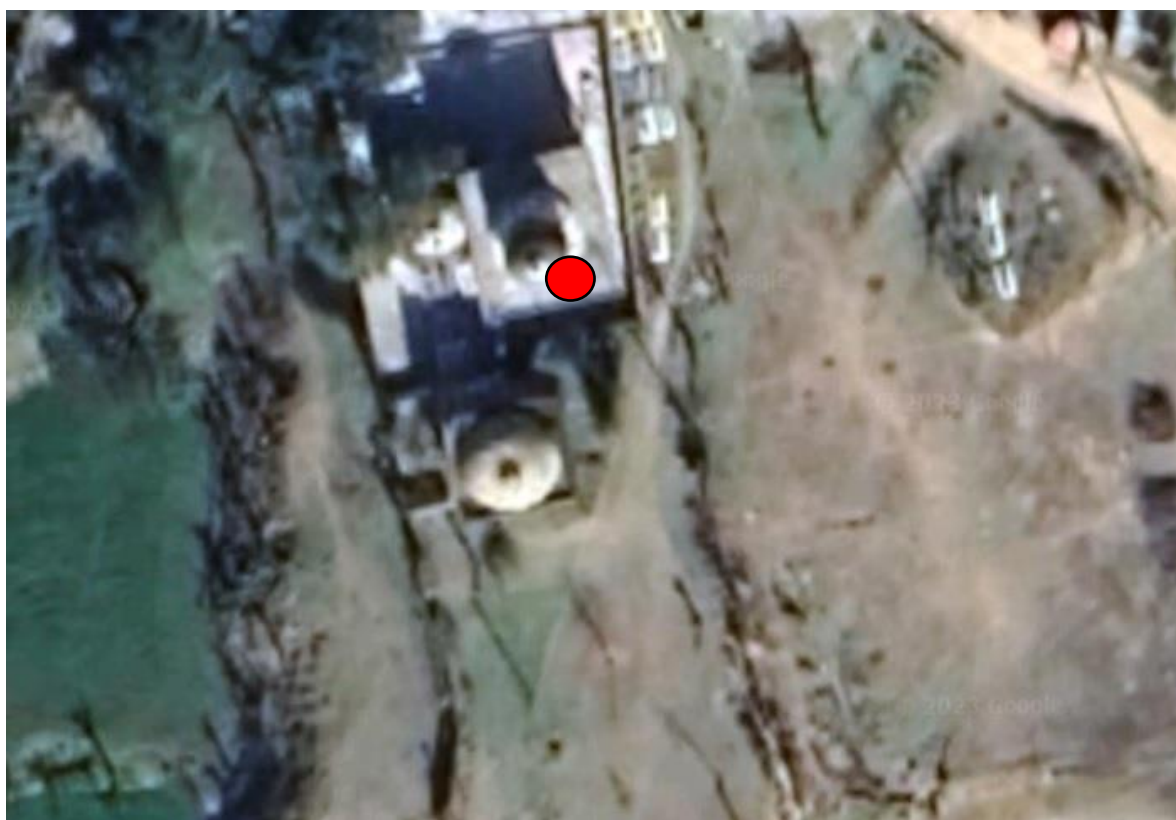
Figure d: Guli Bagh, Mansehra: Layout Plan and sampling area (encircled) (After Google Maps, 2023)
